AFWAL-TR-81-3096

EVALUATION OF SEVERAL BONDING PARAMETERS ON THE RANDOM BENDING FATIGUE LIFE OF ADHESIVELY BONDED ALUMINUM JOINTS

AUGUST 1981

TECHNICAL REPORT AFWAL-TR-81-3096
Final Report for Period June 1978 — November 1980

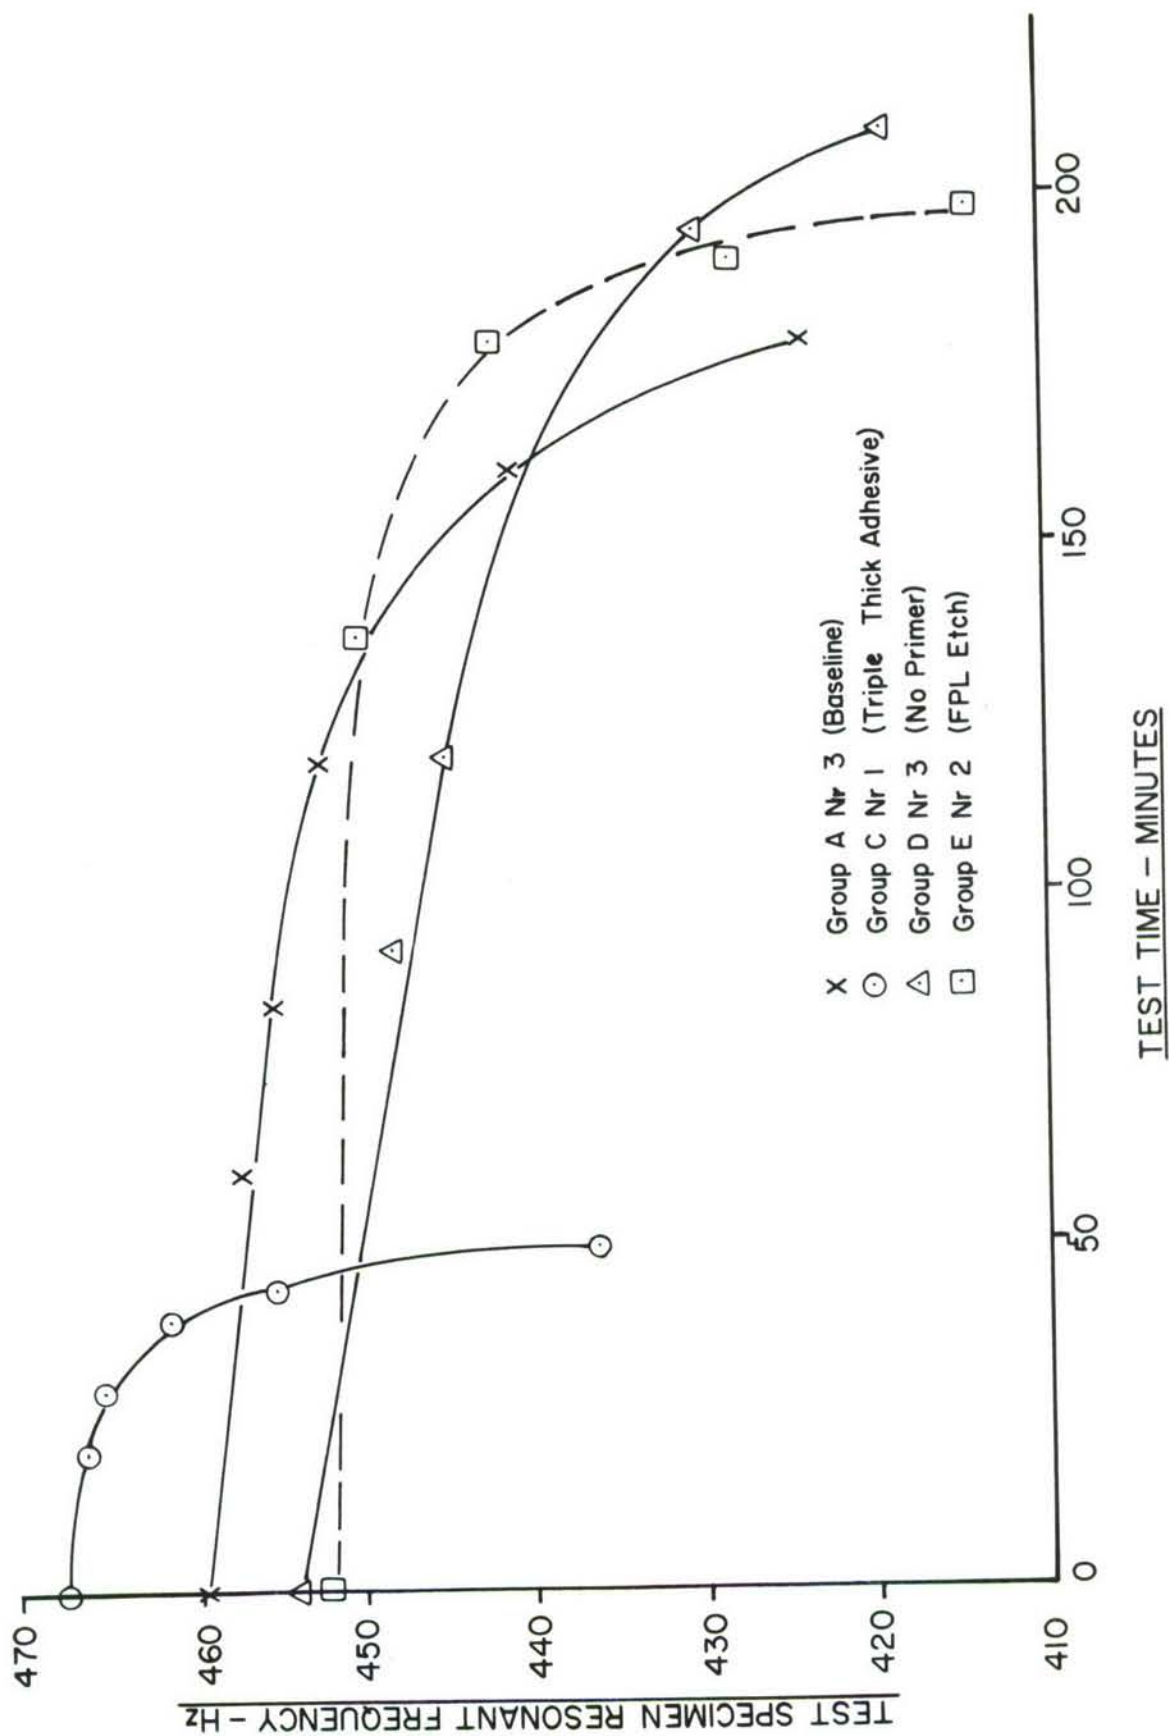
Figure Nr. 10 - Change in Resonant Frequency vs Time

Failure time was determined from visual inspection of each test coupon conducted at 2 to 3 hour intervals, or whenever the coupon response frequency showed a noticeable decrease. When this point was reached, the test was terminated and the time to failure recorded. Figure 10 shows typical time histories of the frequency response. The exact time of crack initiation is not evident from these plots. The change in the slope of the frequency

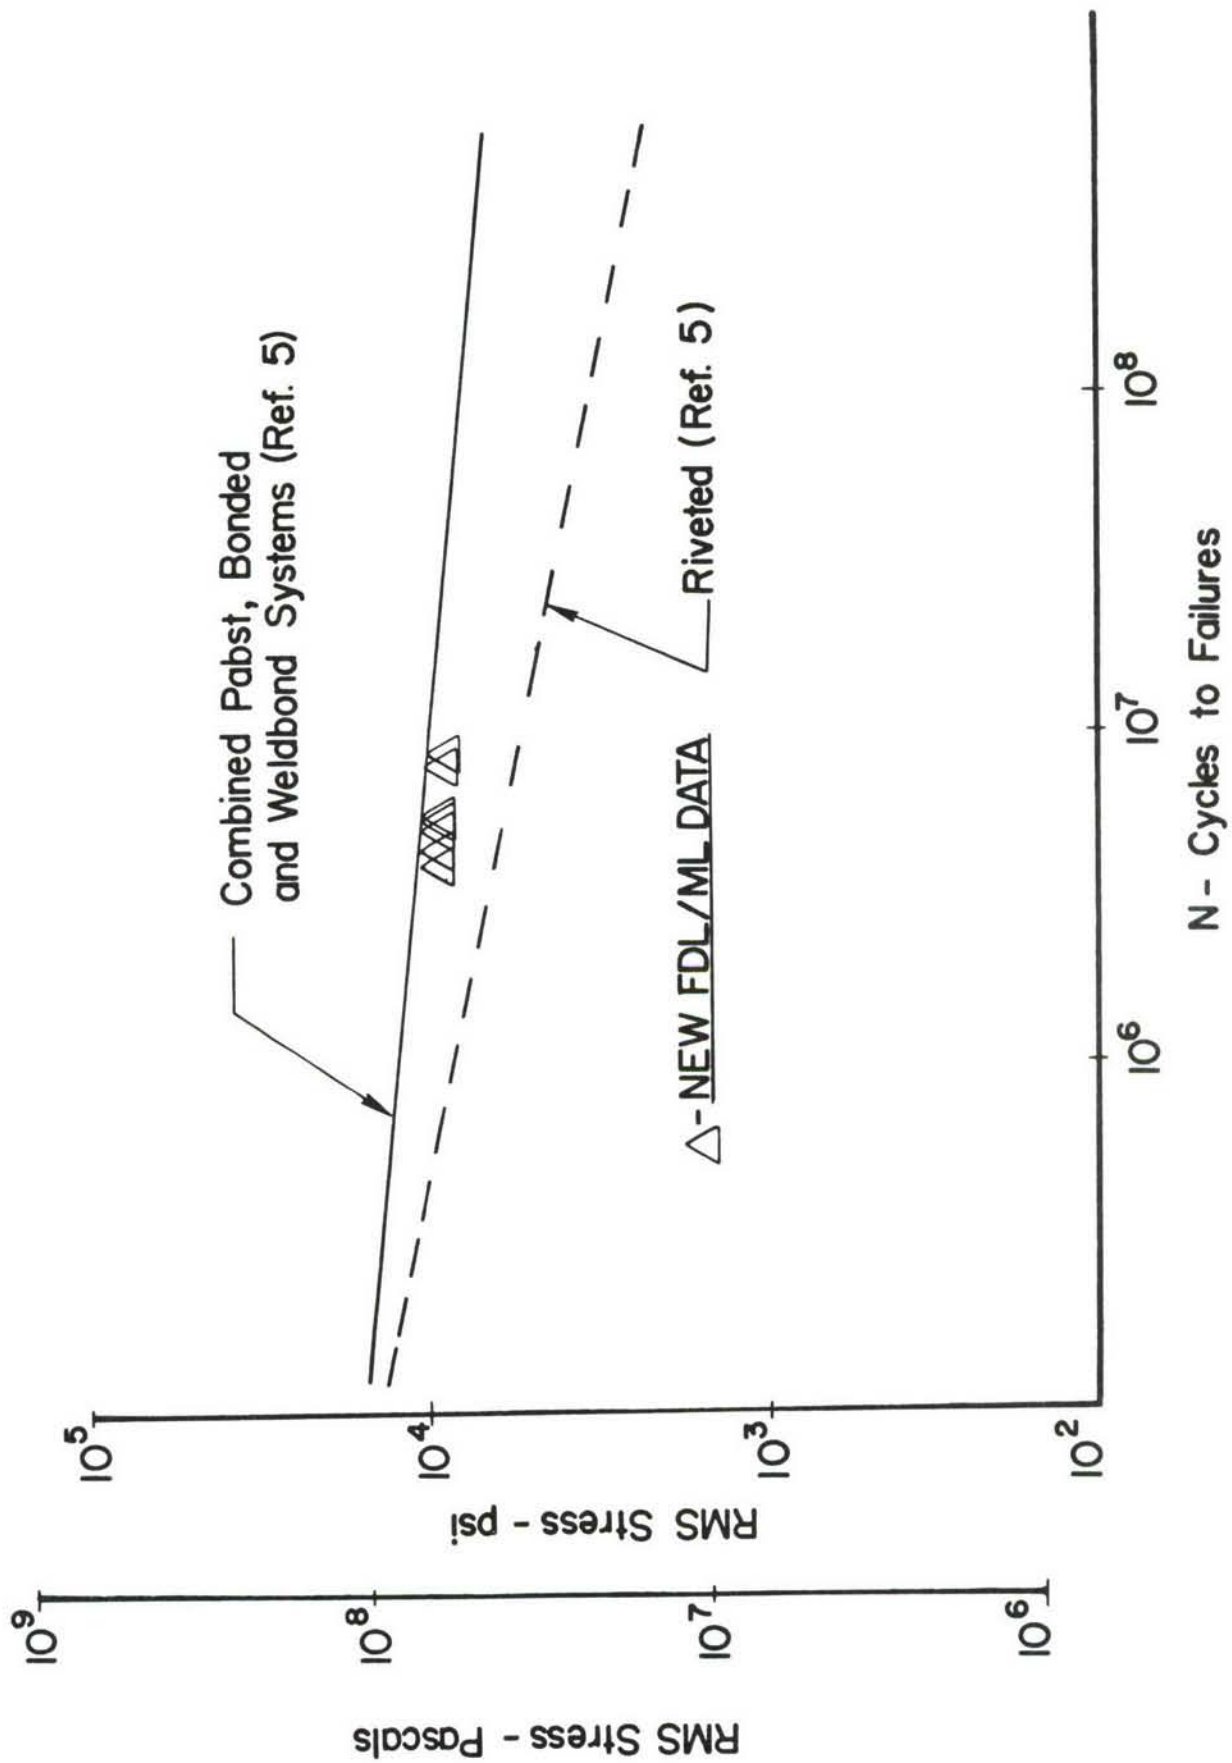
Figure Nr. 11 - Comparison of FDL/ML Skin Failures with Previous Test Data

Since conclusions drawn from a small number of fatigue failures can be misleading, these data were compared with the results from previous investigations and are identified herein as FDL/ML data. The skin failures are plotted in Figure 11 and compared very closely with the S-N curve developed in Reference 5.

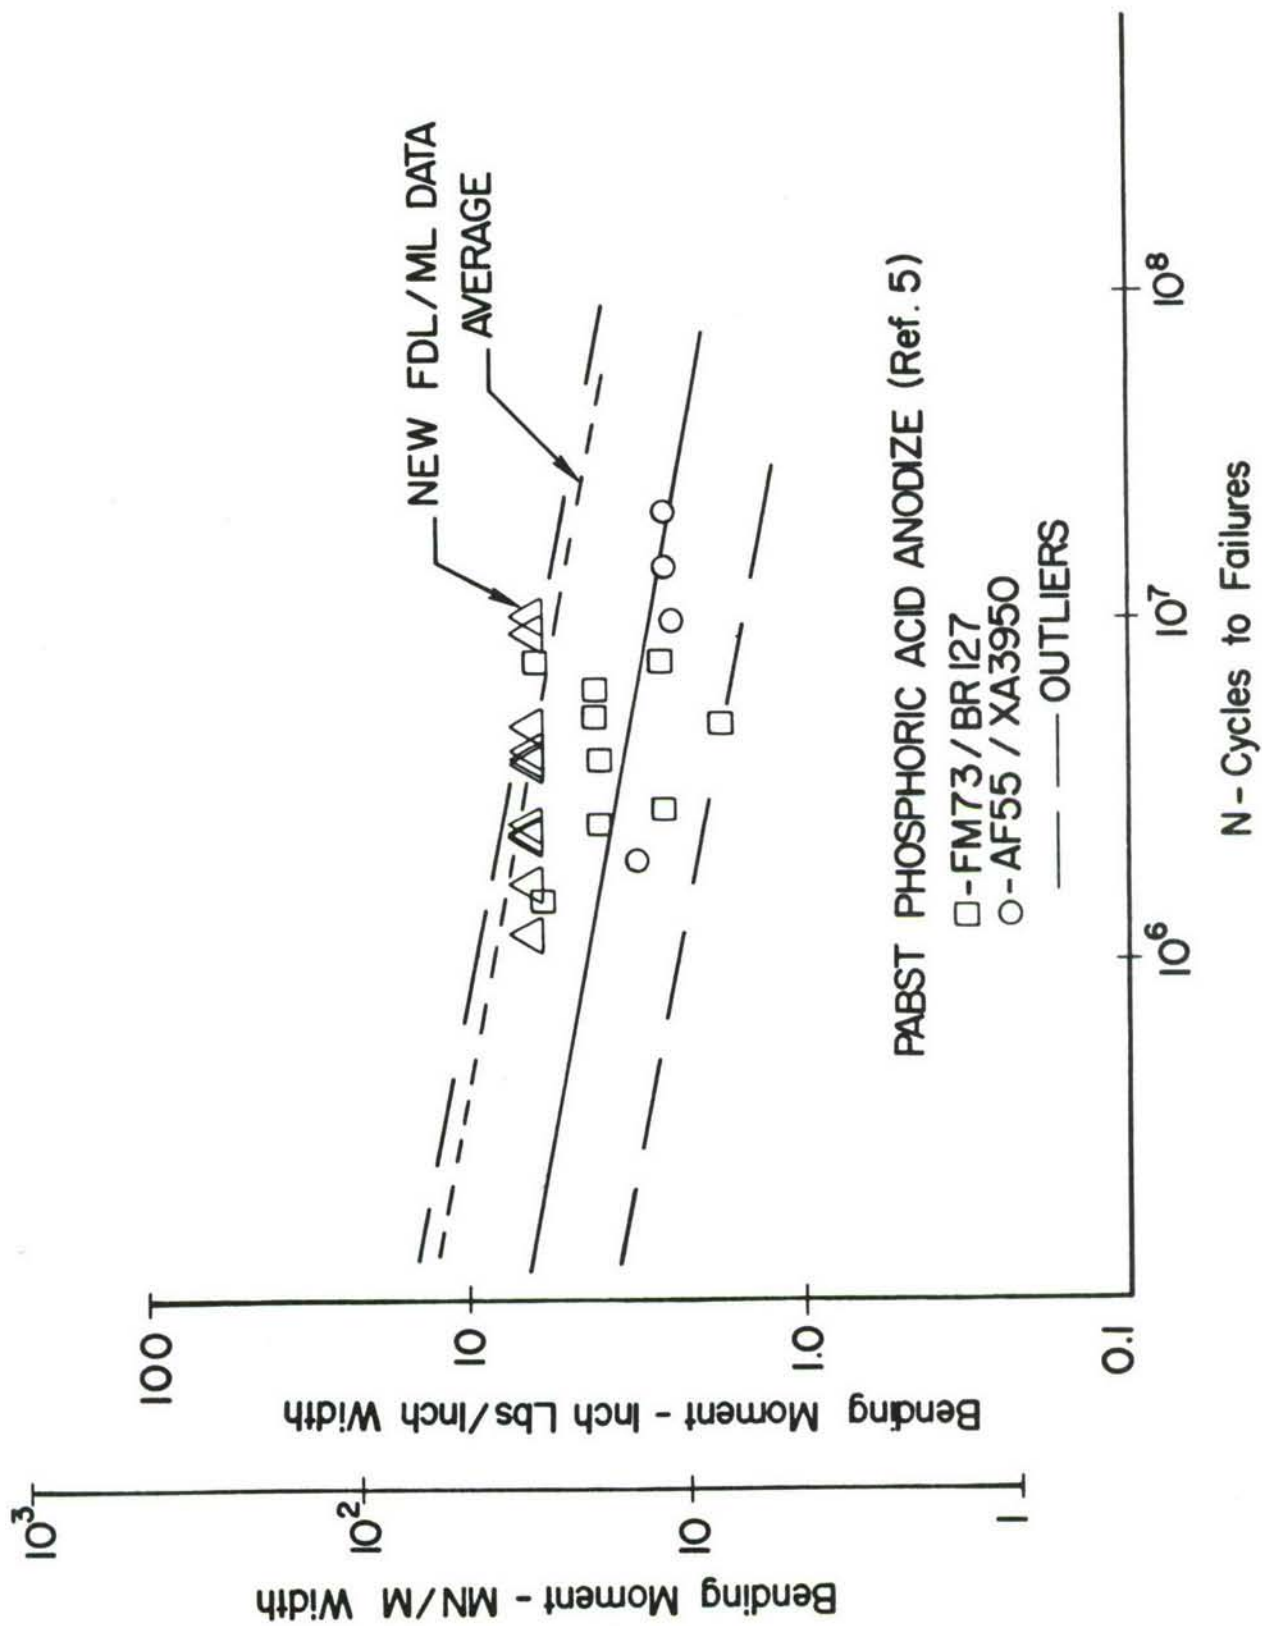
Figure Nr. 12 - Comparison of FDL/ML Bond Failures with PABST Data

Figure 12 shows the 11 new adhesive fatigue failures (FDL/ML data) compared to previous data obtained from FM73 and AF55 adhesives. The dashed lines were constructed through the outlying points of the previous data and are parallel to the previously established M-N curve. Most of the new data fell within these outliers established from the data. A new M-N curve was then constructed from the FDL/ML data through the average value of the fatigue failures and parallel to the previous M-N curve. For a given moment, an increase in life by a factor of approximately 20 can be expected using the M-N curve developed with the FDL/ML fatigue failures.

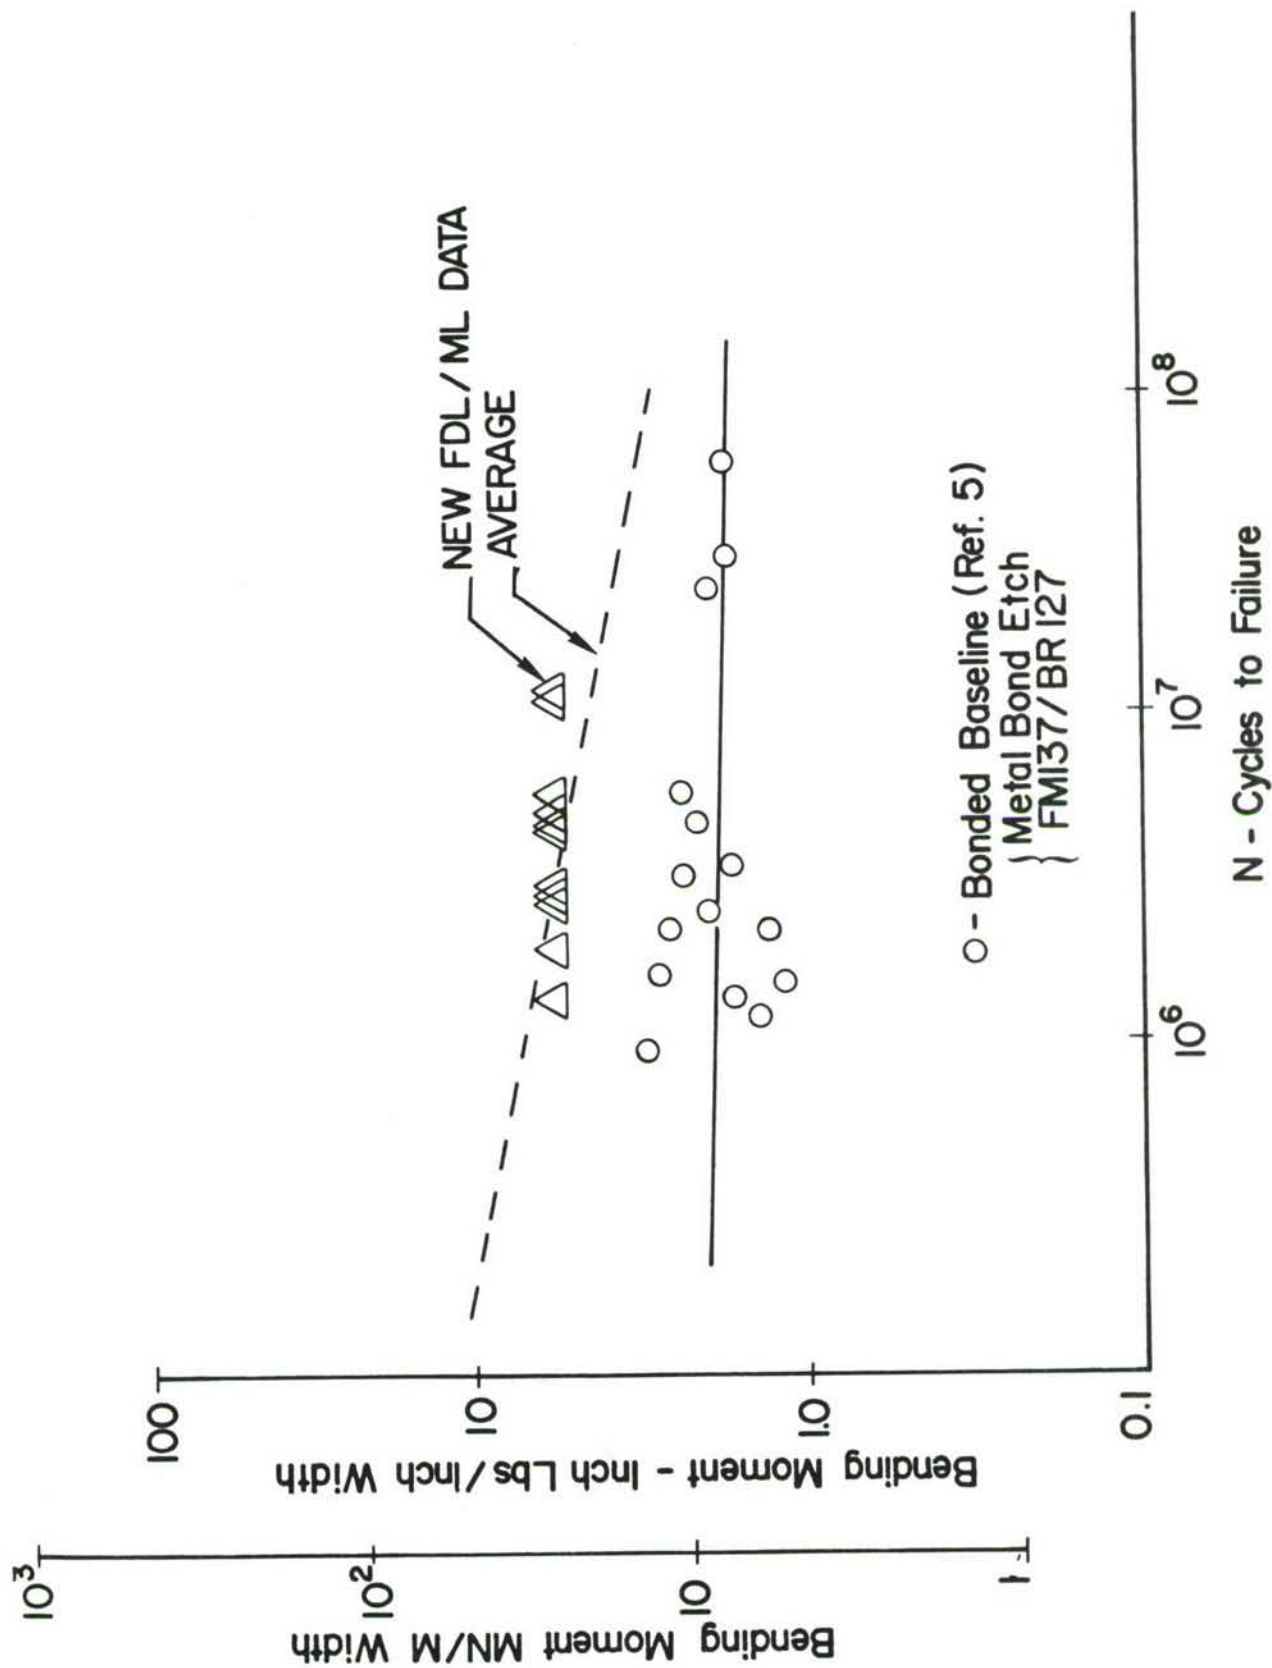
Figure Nr. 13 - Comparison of FDL/ML Bond Failures with Bonded Baseline Data

Figure 13 shows the 11 new adhesive fatigue failures compared with previous data from FM137 adhesive and metal bond etch surface preparation. Fatigue failures with the adhesives used in FDL/ML beam coupons occurred at a higher load than the FM137. The FM137 data produced a very flat M-N curve.

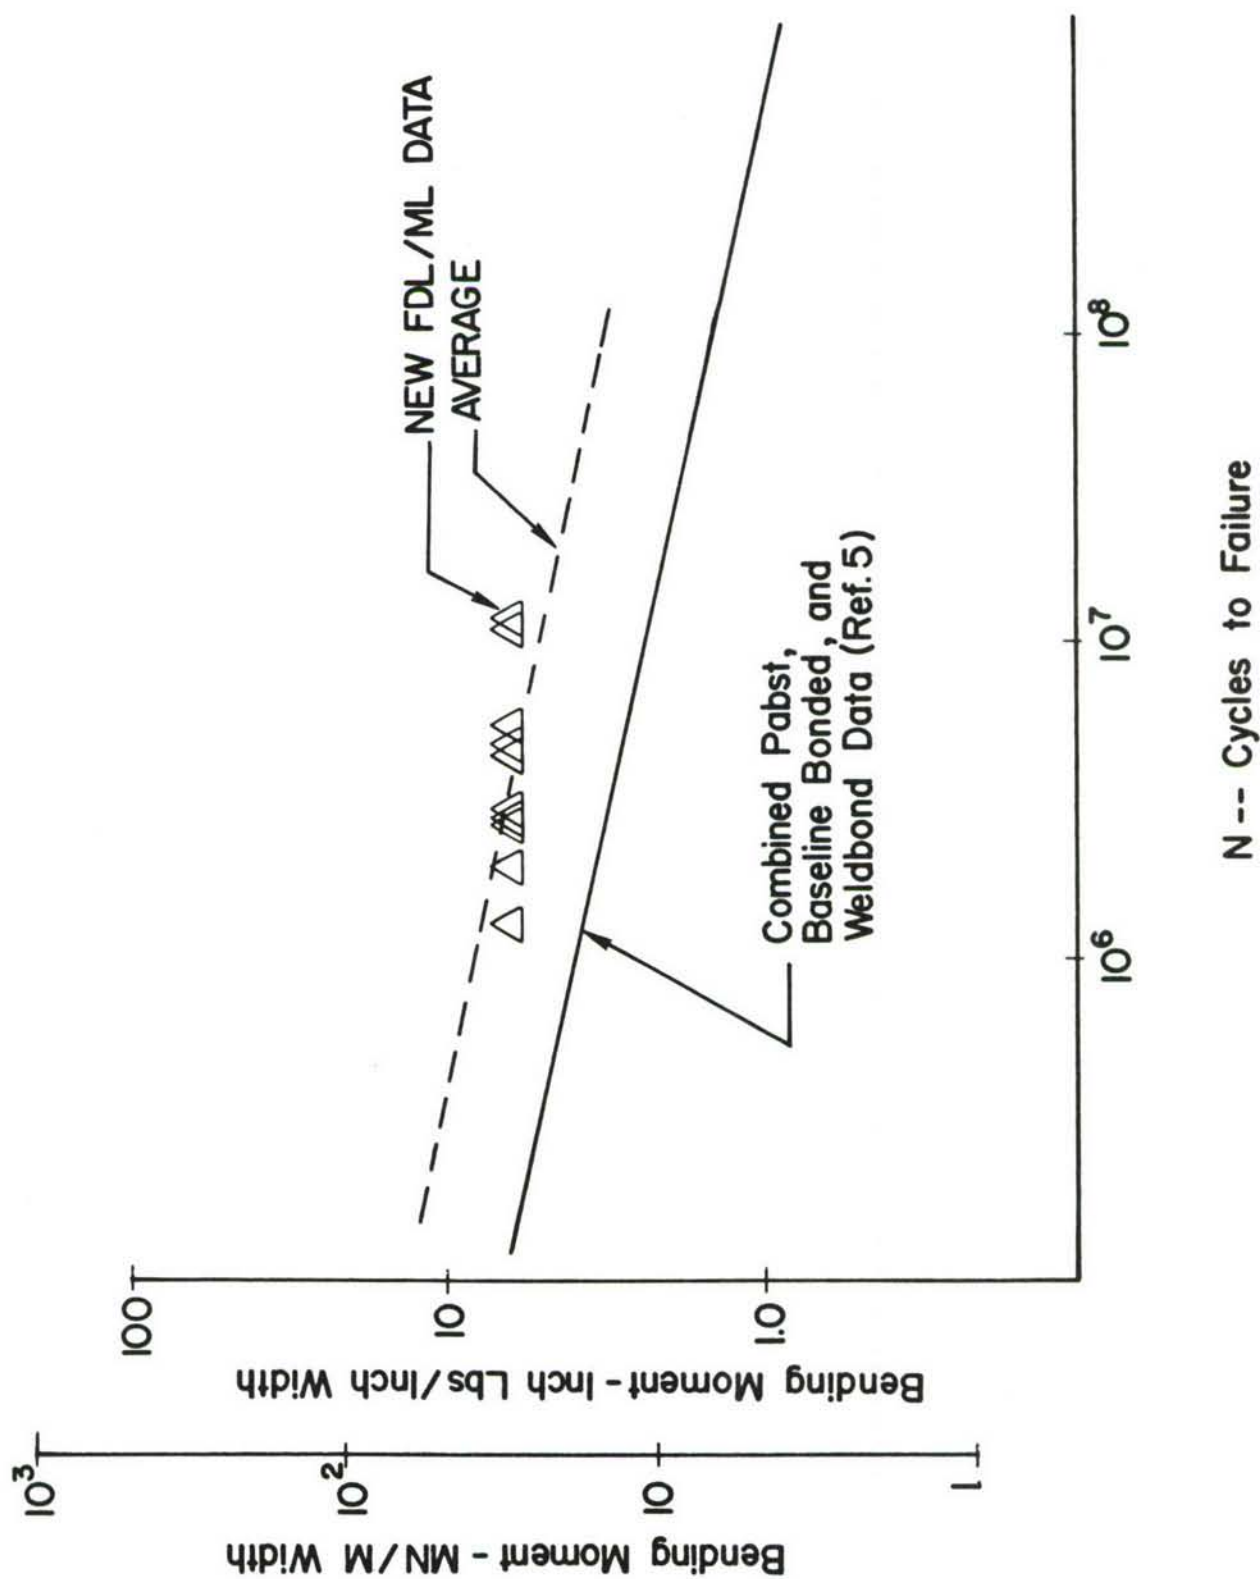
Figure Nr. 14 - Comparison of FDL/ML Bond Failures with Combined PABST, Baseline and Weldbond Data

Figure 14 shows the FDL/ML data and the M-N curve developed using the combined PABST, baseline bonded and weldbonded data.⁵ The M-N curve for the FDL/ML data was constructed through the average value of the fatigue failures and parallel to the previous combined curve. For a given bending moment, it is shown that an increase in life by a factor of approximately 30 can be expected with the M-N curve developed with the FDL/ML fatigue failures.
